Manhole Inspection Summary

Manhole # S45I__065MH

Insp Date: **4/24/08 2:04 PM**

Location Address: **1901 gough st**

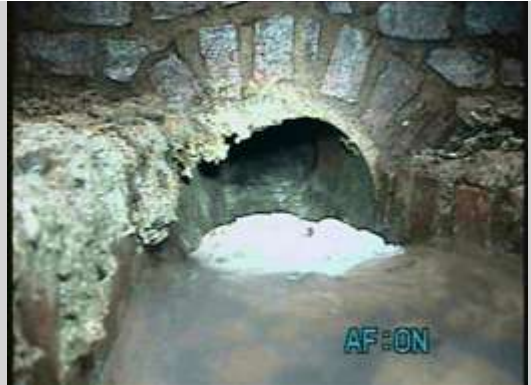
12 O'Clock Outflow

8 in. Circular Gravity Sewer
Pipe Out @ 12 O'Clock

Pipe Material: **Clay** ☐ Pipe Lined

Invert Depth: **10.41** (ft.) Flow Characteristics: **Slow**

Deposits: ☒ None ☐ Mud ☐ Sludge ☐ Debris ☐ Grease

Infiltration: **None** Pipe Seal Cond: **Unknown**

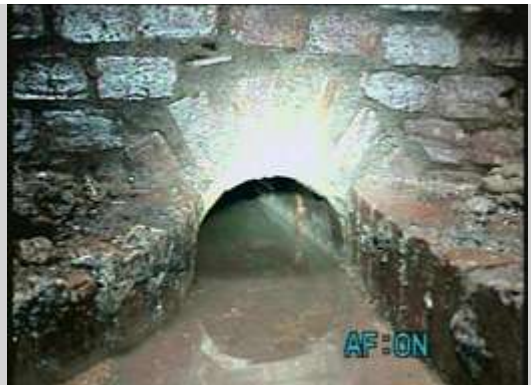
3 O'Clock Inflow

8 in. Circular Gravity Sewer
Pipe In @ 3 O'Clock

Pipe Material: **Clay** ☐ Pipe Lined

Invert Depth: **10.25** (ft.) Flow Characteristics: **Slow**

Deposits: ☒ None ☐ Mud ☐ Sludge ☐ Debris ☐ Grease

Infiltration: **None** Pipe Seal Cond: **Unknown**

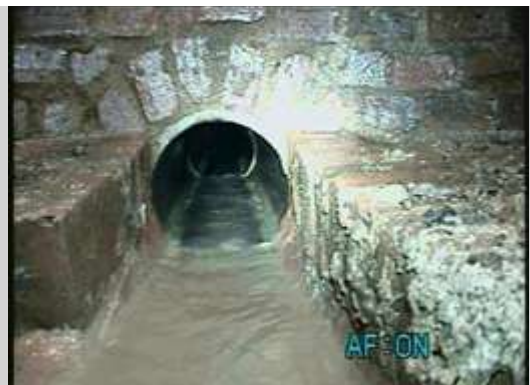
6 O'Clock Inflow

8 in. Circular Gravity Sewer
Pipe In @ 6 O'Clock

Pipe Material: **Clay** ☐ Pipe Lined

Infiltration: **None** Pipe Seal Cond: **Unknown**
